NASA
Engineering Directorate
Materials Science Division
Kennedy Space Center, Florida

KSC-MSL-2011-0045

SUBJECT: Failure Analysis of an EckAdams Office Chair from the Maintenance and Operations (M&O) Building

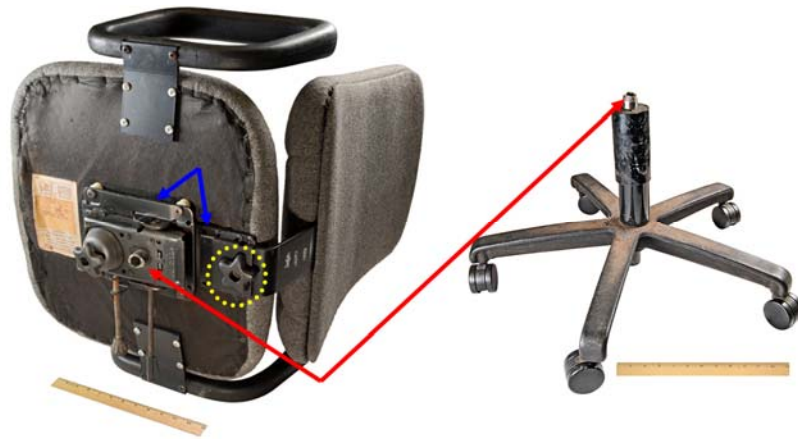
3.1. The chair was photographed, as received (Figure 1), and inspection of the underside of the seat base revealed a manufacturer's tag that dated the chair to January 1994 (Figure 2). The chair was an EckAdams Company model number 5353 ergonomic office chair, order number 131165002. The cylinder fracture was observed to occur at the location where the shaft narrowed down to a smaller cross-sectional area, which would impart a stress concentration in this location

Figure 1. EckAdams office chair, as received. The red arrows indicate the location of the cylinder failure, the yellow circle indicates the location of the chair back adjustment knob, and the blue arrows indicate the locations of the chair back mounting plate and the base plate. Scale is 1 foot.

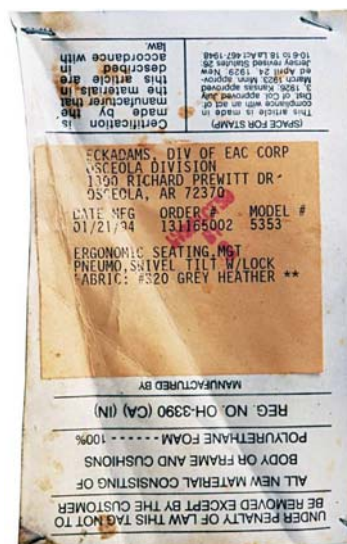
Figure 2. Identification tag from the bottom of the chair.

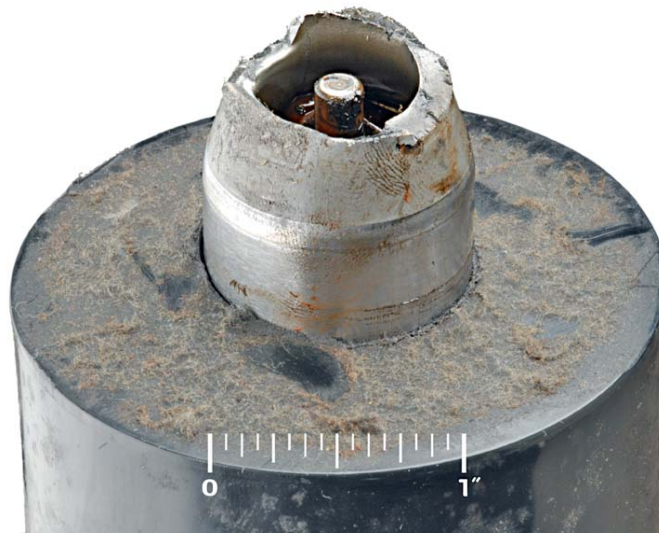
(Figure 3). The chair mechanism on the underside of the seat was disassembled in order to remove the shaft for fractographic inspection. During disassembly, two additional parts were revealed to have failed: an internal-external tooth lock washer under the knob that holds the back of the chair in place (Figure 1, yellow circle and Figure 4) and two tack welds that secured the chair back mounting plate to the base plate (Figure 1, blue arrows and Figure 5). The fractured washer probably did not contribute to the cylinder failure, but may be an indication of the amount of force that was exerted on the tightening knob or the chair back. The separated welds could have allowed more stress to be imparted to the cylinder of the chair during reclining due to reduced stiffness in the mounting plate.

Figure 3. Photograph of the cylinder failure, showing the narrowing of the cylinder in this location. Scale is one inch.

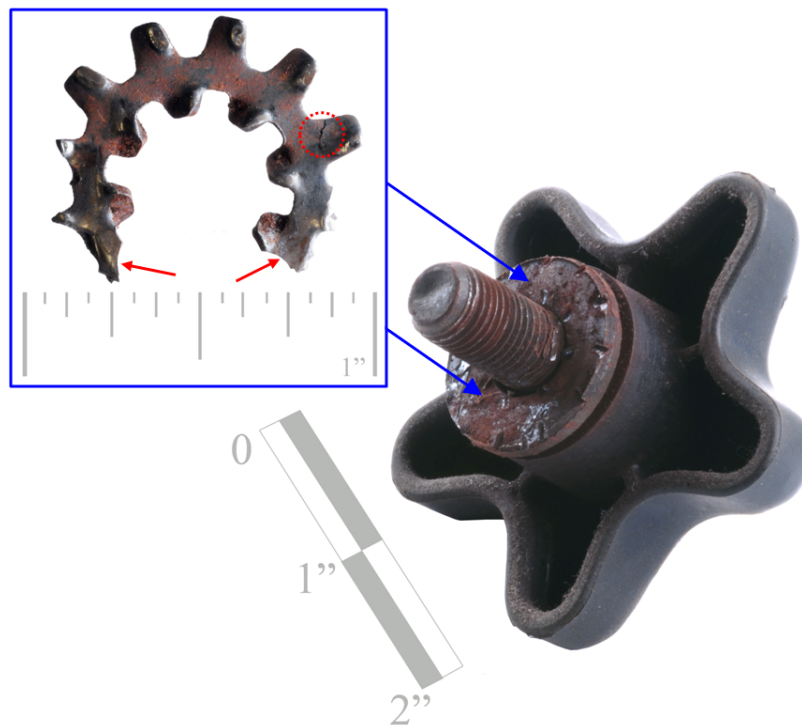
Figure 4. Photograph of the internal-external tooth lock washer that was observed to be fractured (arrows and circle) after removal of the chair back tightening knob (right). Scales are in inches.

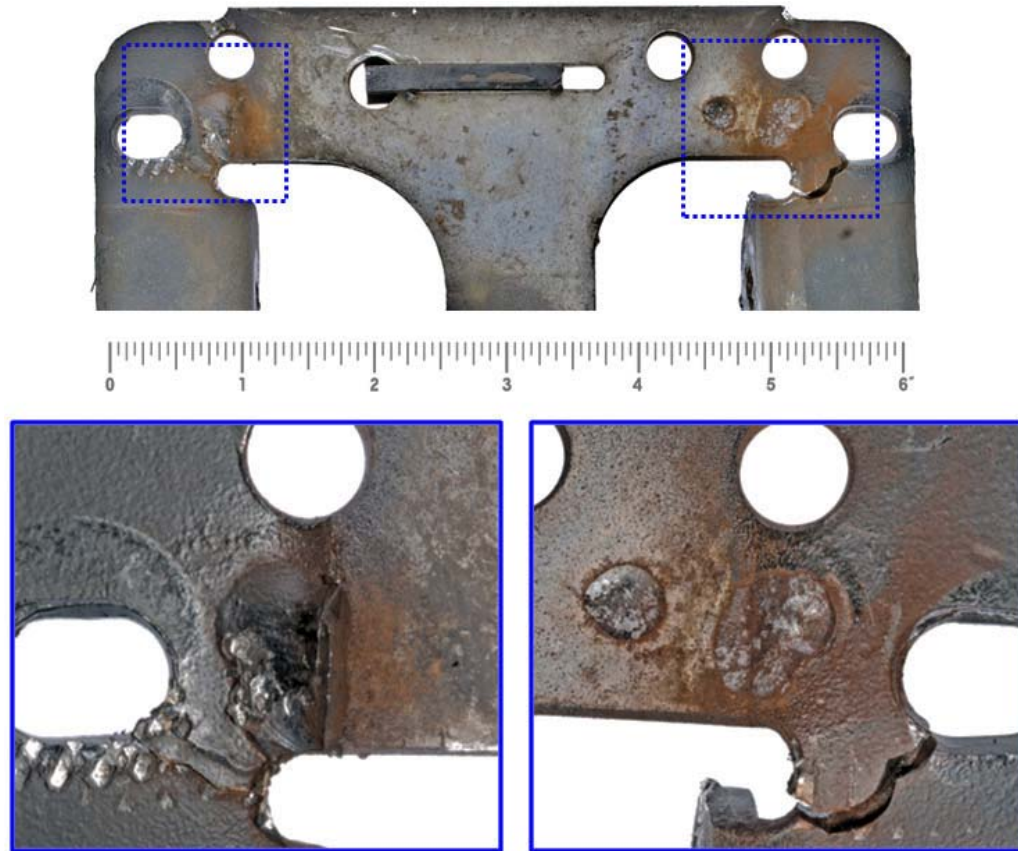
Figure 5. Photographs of the two locations where tack welds had liberated on the chair base plate and a fracture that was observed near one of the welds (right image). Scale is six inches.

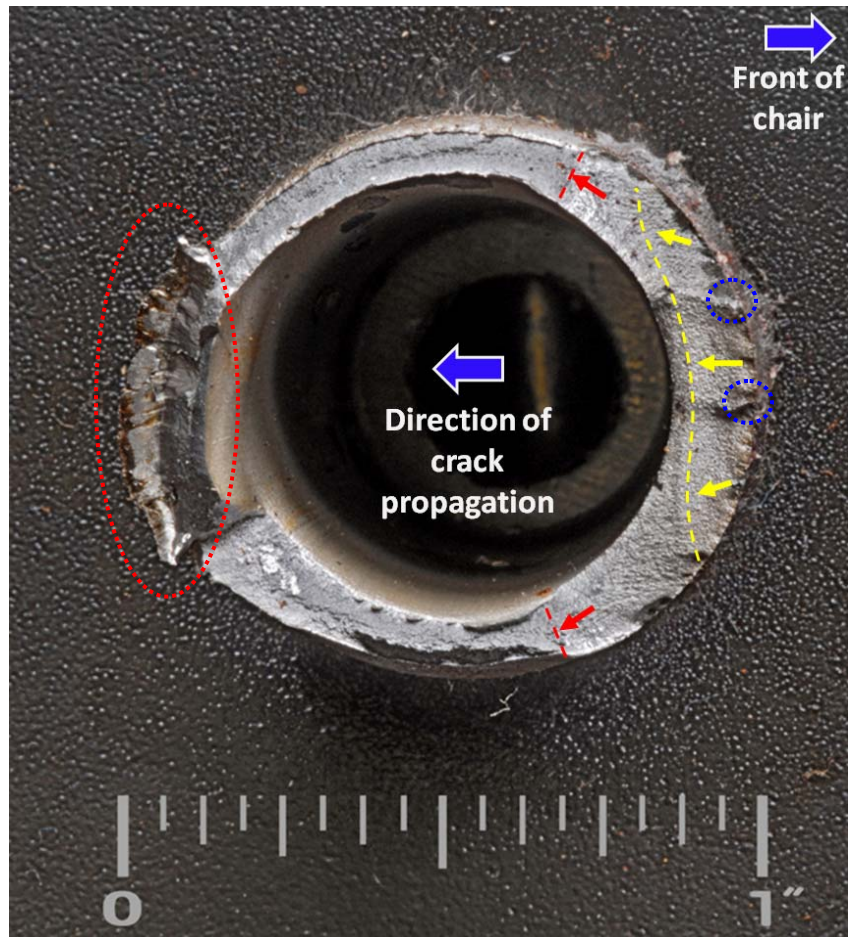
- 3.2. Stereomicroscope observation of the fractured shaft revealed different regions on the fracture surface. The crack appeared to initiate towards the front of the chair and propagate towards the back (Figure 6, blue arrows). Ratchet markings were observed towards this side of the cylinder (Figure 6, blue circles), which are indications of multiple crack origins and are one macroscopic indication of fatigue. The initial region of the fracture surface was relatively flat and displayed faint beach marks (Figure 6, yellow line), which are marks left behind by the crack front when the applied stress is removed for a period of time; this is another macroscopic indication of fatigue. The fracture surface then had a distinct change in appearance approximately one-third of the distance through the cylinder (Figure 6, red line). The final region of the fracture surface displayed a shear lip as the final portion of the cylinder failed and smeared the metal on the fracture surface (Figure 6, red oval).

Figure 6. Stereomicroscope image of the cylinder fracture surface showing ratchet markings at the side of the cylinder where crack initiation occurred (blue circles); a beach mark observed on the fracture surface (yellow line); and the distinct area on the fracture surface where the crack path was no longer flat and relatively smooth (red lines). The yellow and red arrows show the direction of crack propagation through the cylinder. Scale is one inch.

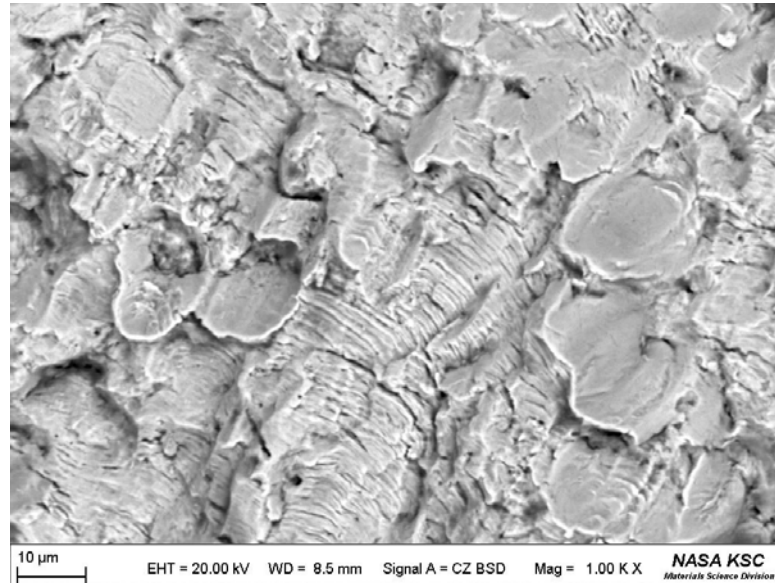
- 3.3. Scanning electron microscope (SEM) evaluation of the flat region of the fracture surface observed via stereomicroscope revealed striations, which are microscopic indications of the fatigue crack front progression through the material with a cycle of applied stress (Figure 7). Areas of smeared metal were also observed, which is typical during a fatigue fracture due to the mechanical contact of the two mating halves of the fracture surface as stress is applied and removed. SEM observation of the distinct transition line on the fracture surface observed via stereomicroscope revealed the onset of stress overload, as indicated by the observation of dimpled rupture formed by microvoid coalescence (Figure 8, red box). Just prior to the transition line (Figure 8, yellow arrow), faint fatigue striations were observed along with secondary cracking of the fracture surface (Figure 8, blue box), which occurred just before the final stress overload of the cylinder.

Figure 7. SEM image of the fracture surface showing fatigue striations and small areas of smeared metal. Original magnification: 1,000X.

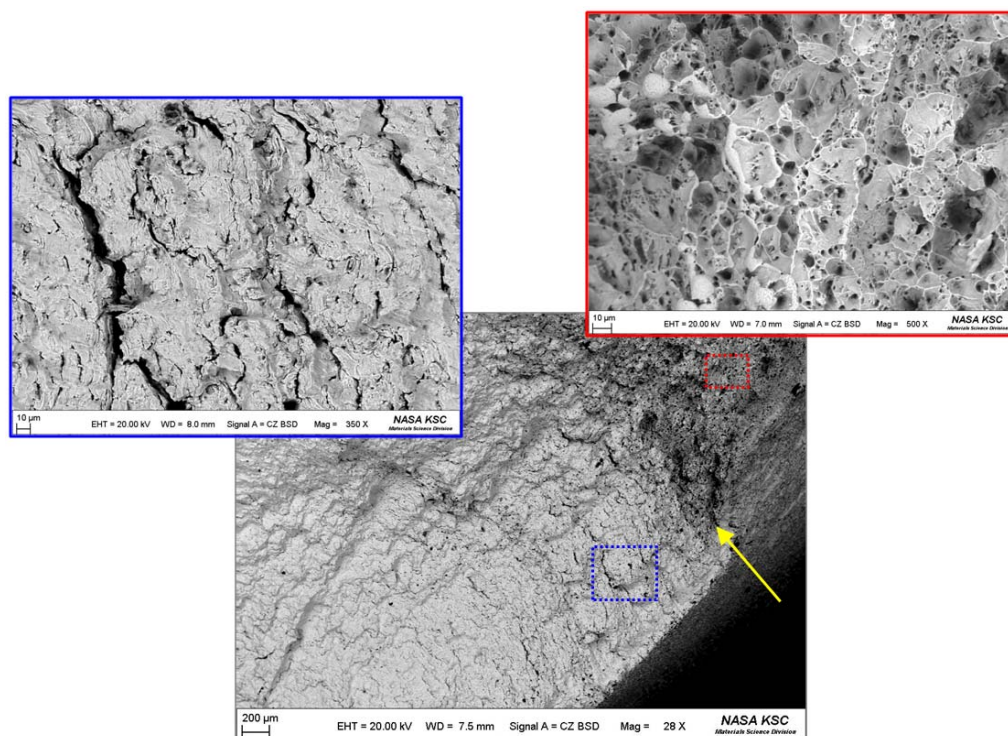
Figure 8. SEM images of the transition line observed on the fracture surface (yellow line). The fatigue fracture started to form secondary cracks (blue box) just prior to the onset of the final stress overload region, characterized by dimpled rupture (red box). Original magnifications: 28X (center), 350X (blue box), 500X (red box).

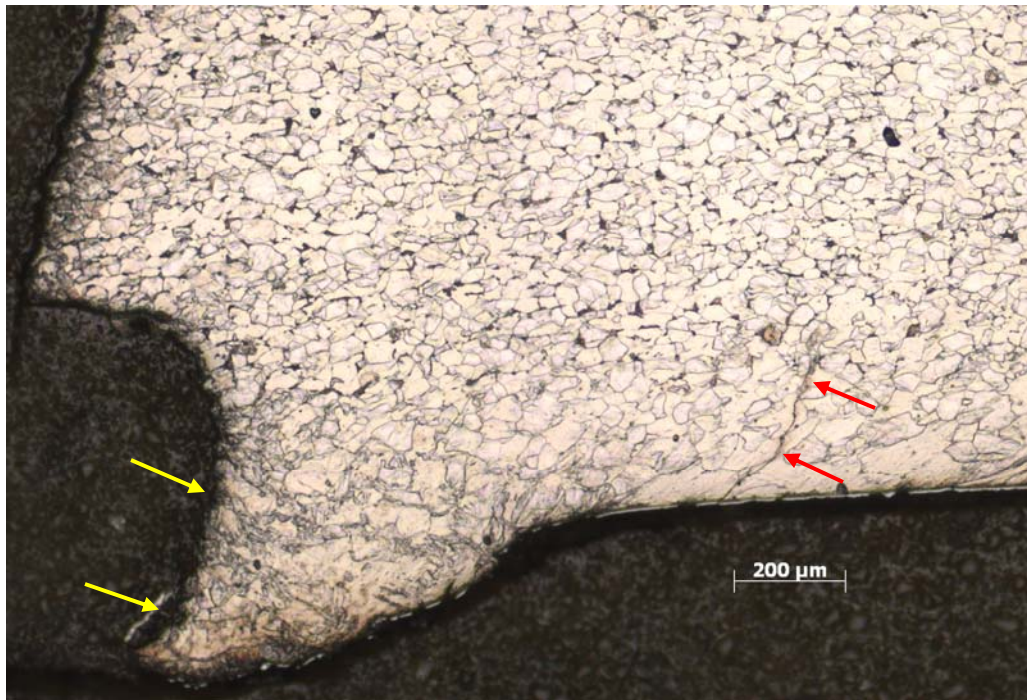
- 3.5. A cross-section of the cylinder through the fracture surface and a cross-section of the base plate at the location of a failed tack weld were metallographically prepared for microstructural examination. An additional transgranular crack was observed to be propagating roughly parallel to the primary fracture surface in the cylinder, which is typical for fatigue (Figure 9, arrows). The microstructure of the cylinder was primarily ferrite with small regions of pearlite, which is typical for normalized plain carbon steel. No indications of any deficiencies were observed in the cylinder material. Examination of the cross-section of the base plate where the tack weld had failed showed a heat-affected zone in the material that was between 200 and 300 microns deep (Figure 10, boxed area). No dendritic structure was observed in this area, which would be present if fusion had occurred. The microstructure of the base metal was ferrite, which is typical for plain carbon steel.

Figure 9. Micrograph of a cross-section of the cylinder near the primary fracture surface showing a microstructure typical for plain carbon steel and a transgranular crack (red arrows) propagating roughly parallel to the primary fracture surface (yellow arrows). Etchant: 2% nital. Original magnification: 100X

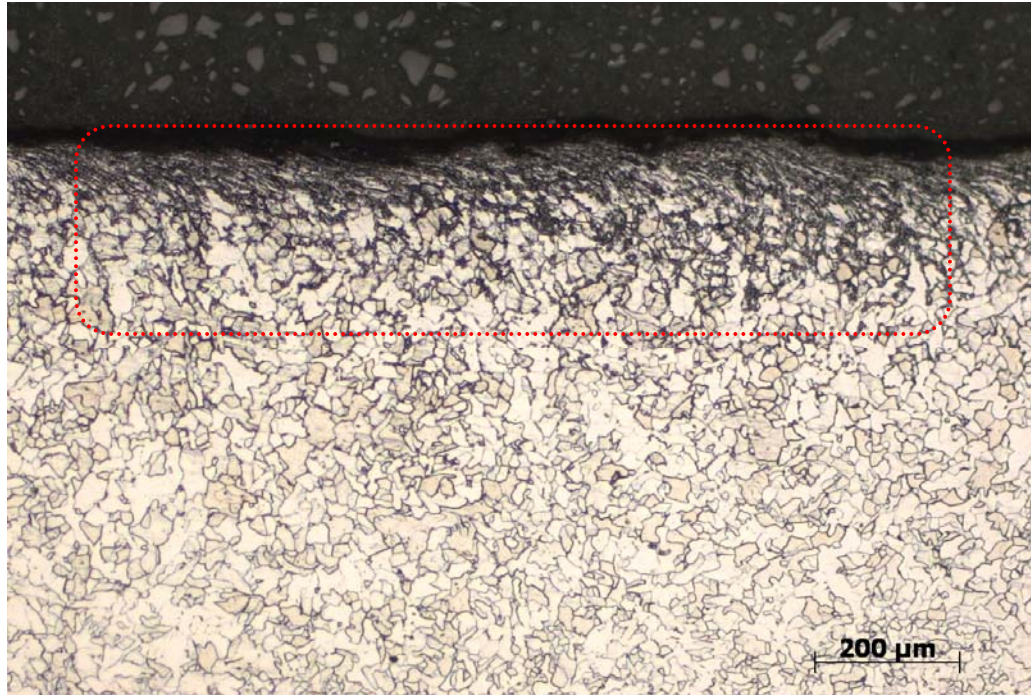
Figure 10. Micrograph of a cross-section of the base plate showing the lack of penetration achieved during tack welding of the chair back plate. No dendritic structure was observed to indicate that fusion had occurred. Etchant: 2% nital. Original magnification: 100X.

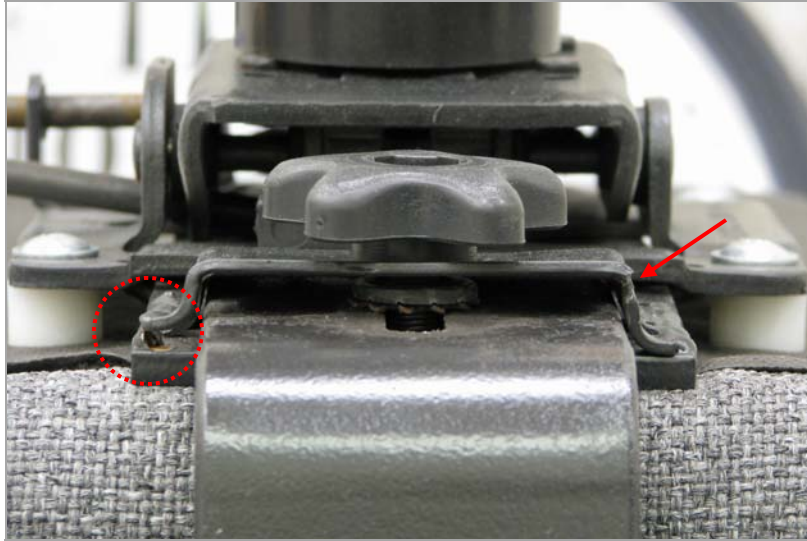
During this investigation, an EckAdams chair with the same model number as the subject chair was observed in the Materials Failure Analysis Laboratory located in the Operations and Checkout (O&C) Building, M7-0355, Room 2217. Examination of the chair revealed one failed tack weld in the bracket that holds the back of the chair in place (Figure 11, circled) and a crack in the bracket opposite this weld (Figure 11, arrow). The tack weld likely failed first due to the stress imparted by the chair back, leading to subsequent cracking of the bracket. Although this failure was not in the same location, the observation of failed tack welds in more than one EckAdams model number 5353 chair is an indication that the failure in the subject analysis may not be an isolated case.

Figure 11. Photograph of a failed weld (circle) and a crack (arrow) in the chair back mounting bracket on an EckAdams chair observed in the Materials Failure Analysis Laboratory. Oblique view.
